# Manhole Inspection Summary

Manhole # S41A\_\_034MH

Insp Date: **7/18/08 8:46 AM**

**Location** Address: **528 mcelderry st**

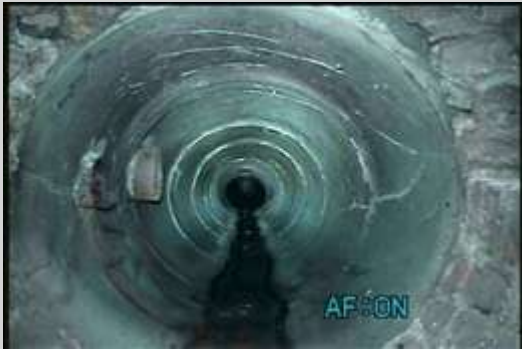
12 O'Clock Outflow

15 in. Circular Gravity Sewer  
Pipe Out @ 12 O'Clock

Pipe Material: **Clay** ☐ Pipe Lined

Invert Depth: 7.30 (ft.) Flow Characteristics: **Fast**

Deposits: ☒ None ☐ Mud ☐ Sludge ☐ Debris ☐ Grease

Infiltration: **None** Pipe Seal Cond: **Unknown**

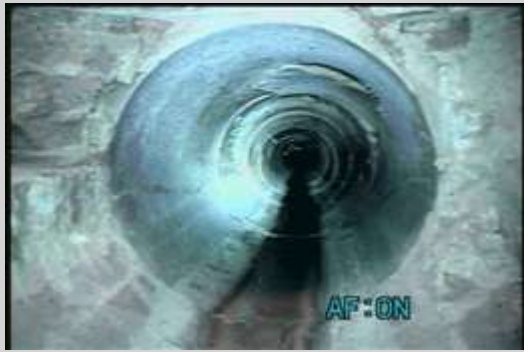
6 O'Clock Inflow

15 in. Circular Gravity Sewer

Pipe In @ 6 O'Clock

Pipe Material: **Clay** ☐ Pipe Lined

Invert Depth: **7.09** (ft.) Flow Characteristics: **Fast**

Deposits: ☒ None ☐ Mud ☐ Sludge ☐ Debris ☐ Grease

Infiltration: **None**

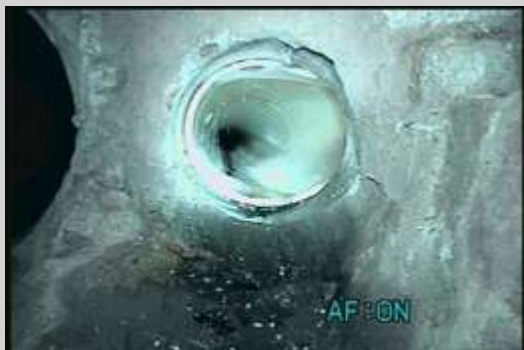
8 O'Clock Inflow

10 in. Circular Gravity Sewer

Pipe In @ 8 O'Clock

Pipe Material: **Clay** ☐ Pipe Lined

Infiltration: **None**
